**United States
Department of
Agriculture**

**Soil
Conservation
Service**

Upper Housatonic River Basin Study

Berkshire County Massachusetts

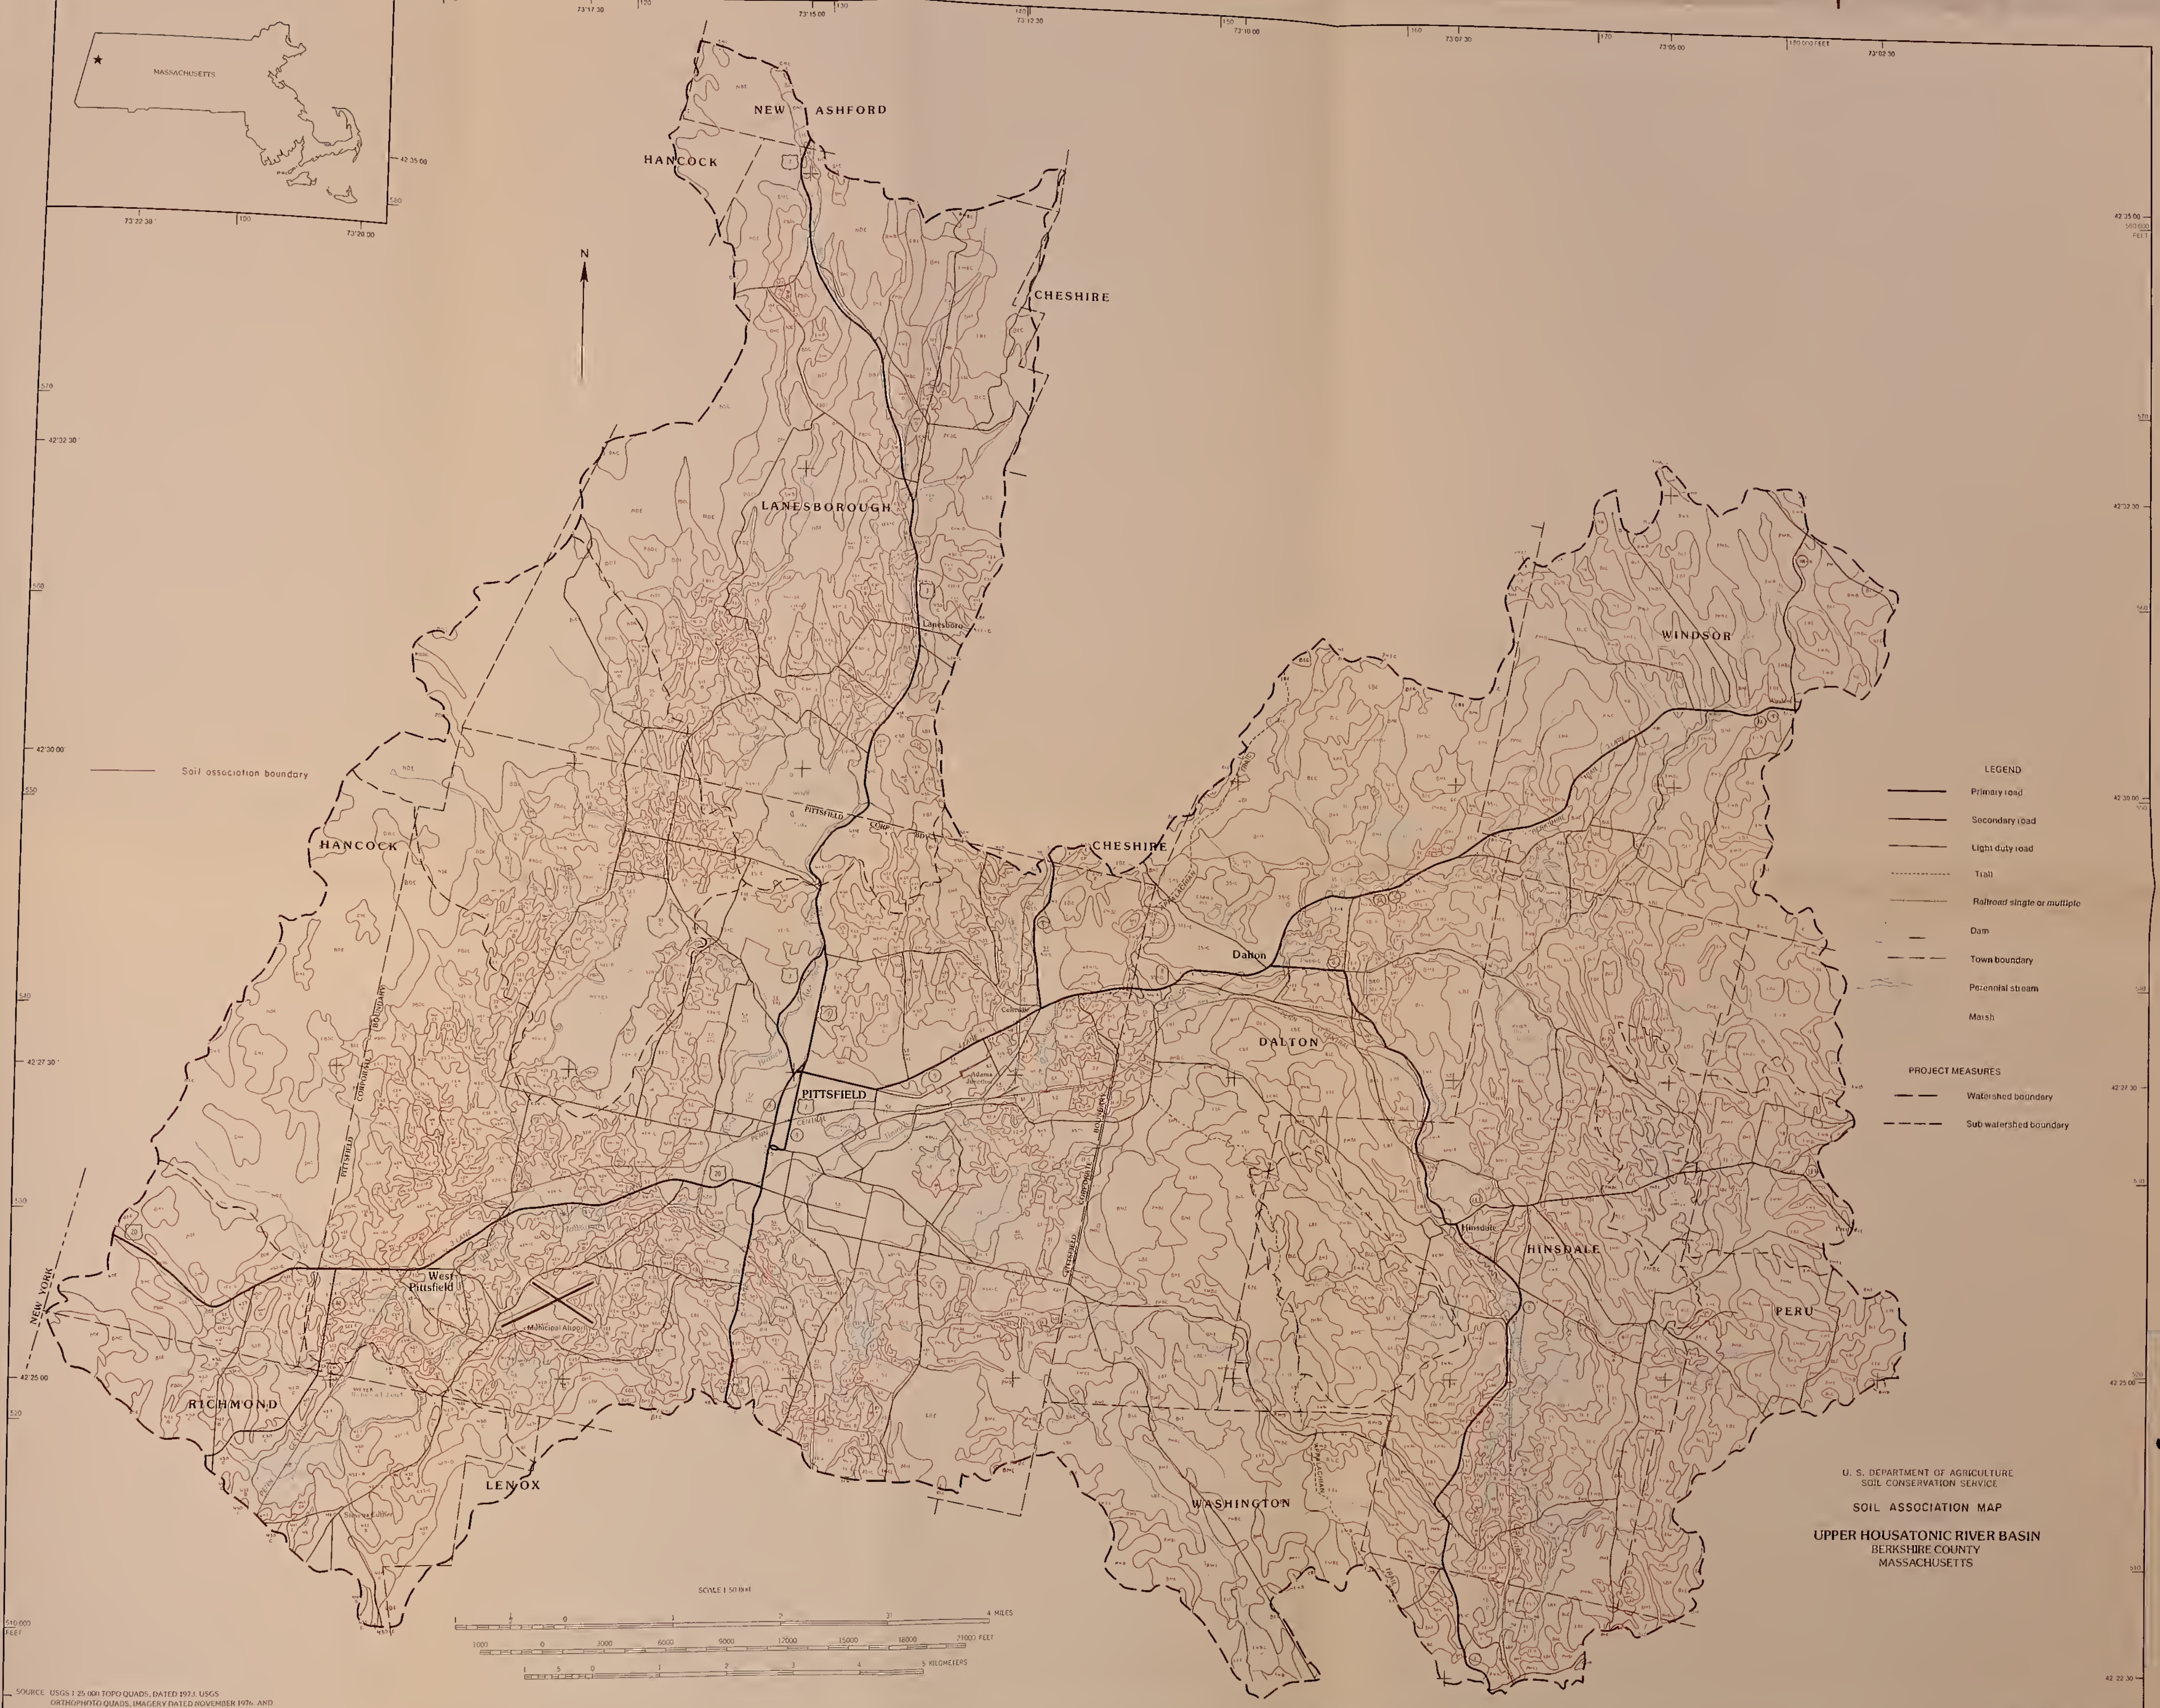
U. S. DEPARTMENT OF AGRICULTURE
SOIL CONSERVATION SERVICE
SOIL ASSOCIATION MAP
UPPER HOUSATONIC RIVER BASIN
BERKSHIRE COUNTY
MASSACHUSETTS

Figure 3 presents the soils of the river basin. Material to prepare this map was obtained from preliminary field data and is subject to revision.

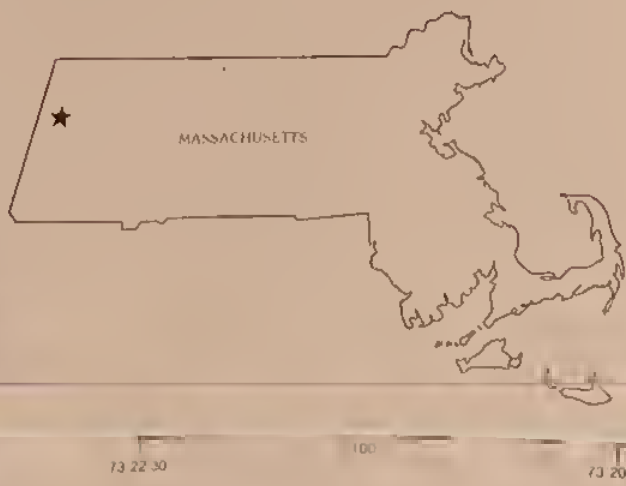
U. S. DEPARTMENT OF AGRICULTURE
SOIL CONSERVATION SERVICE
GENERALIZED LAND-USE MAP
UPPER HOUSATONIC RIVER BASIN
BERKSHIRE COUNTY
MASSACHUSETTS
JUNE 1981

COPIED FROM 1:250,000 TOPOGRAPHIC MAPS
USGS PHOTO QUADS, IMAGERY DATED 1970-1979, AND
RANDOM DAILY ROAD ATLAS, 1970 EDITION
